Rain-Induced Slope Instability: Case Study of Monsoon 2020 Affected Villages in Pithoragarh District of Uttarakhand, India

Sushil Khanduri^{1*}

¹Uttarakhand State Disaster Management Authority, Department of Disaster Management, Uttarakhand Secretariat, 4 Subhash Road, Dehradun-248001, Uttarakhand, India

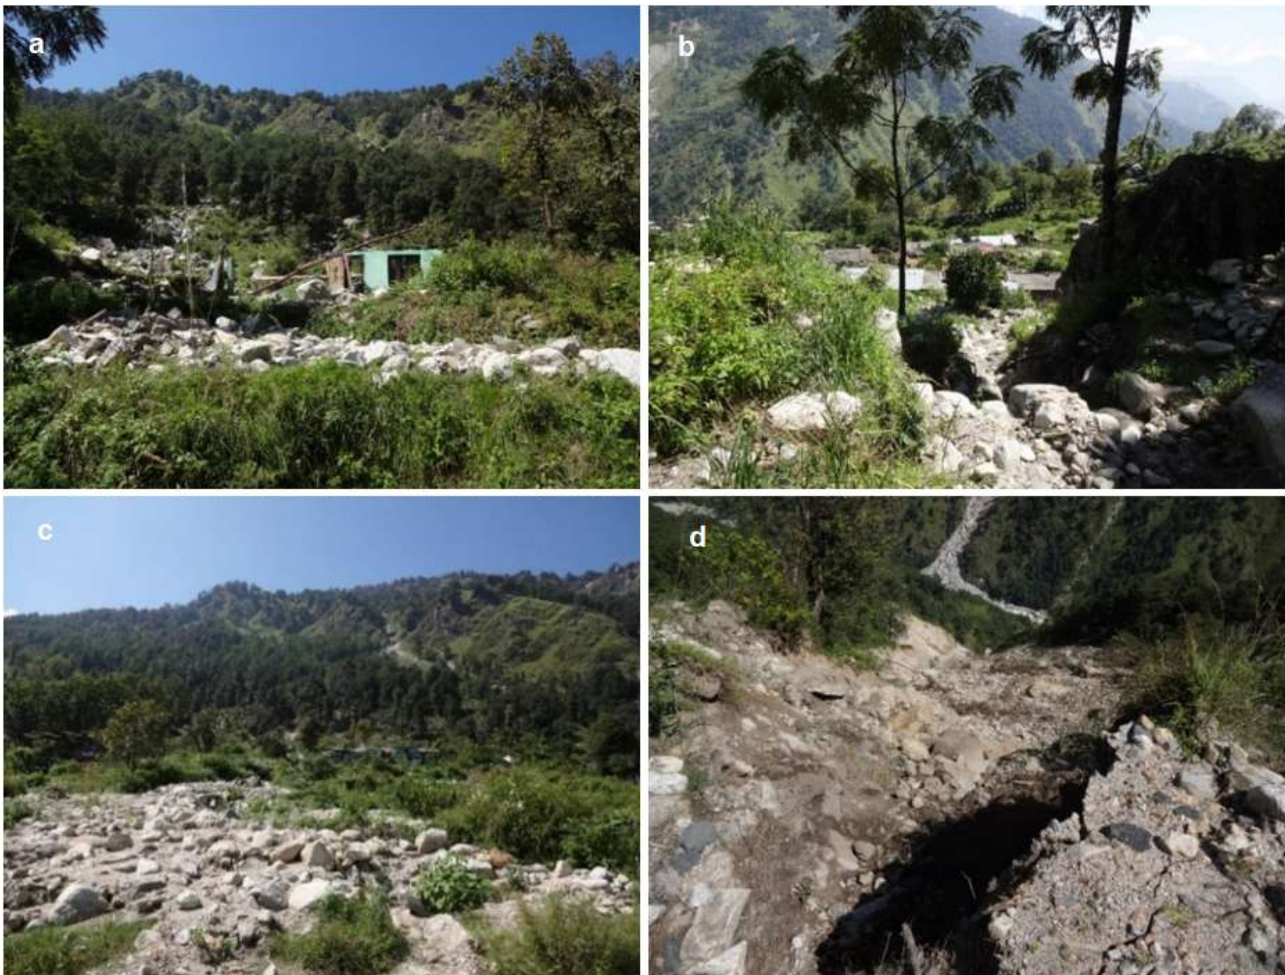
Exposures of Central Crystalline gneisses are observed along the road section around the village. These are generally observed to strike E-W with moderate dips towards due N. Other two prominent joints were observed to dip towards SSW and ENE at steep angles (60°/200° and 55°/80°). The three small streams namely De Dhar nala, Chhida Nala and Humti Nala are flowing through the same slopes. The east flowing streams together with water saturated boundary debris are observed to have overrun residential houses of the village (Fig. 4a). Steep slope accompanied with heavy discharge of water saturated debris with boulders is deduced to have aggravated the pace of erosion along the streams and had high erosion potential to create deep gullies through the village (Fig. 4b).

Fig. 4. Heavy rains triggered debris flows related damages and destructions in Dhapa Village; (a) houses destroyed by water saturated bouldary debris, (b) deep gully due to fast pace of erosion by stream, (c) bouldary debris accumulated in agricultural fields and (d) landslide triggered by water action

Amongst these, 4 houses were destroyed while the others 13 houses were partially damaged and filled with debris. Total of 8 Cows and 8 Goats were lost while a child with his mother flowed down with water saturated debris and seriously injured in these incidences. The bouldary debris flows that descended down from the area upslope of the village was also

observed to have overrun road and a number of agricultural fields (Fig.4c).

Apart from a major debris slide is to be observed on the valley side slope having steep gradient due to aggressive gully erosion by the streams and excessive rains (Fig.4d).

Recommendation: Geologically, the Dhapa Village is not found suitable for habitation because of habitation placed on stream course and activation of overburden materials which laid on uphill slope have the potential of posing danger to the village, particularly during heavy or prolonged rainfall which may flow down with the streams. It is therefore advised that the inhabitants of the affected area should be evacuated to safer places before the onset of monsoon.

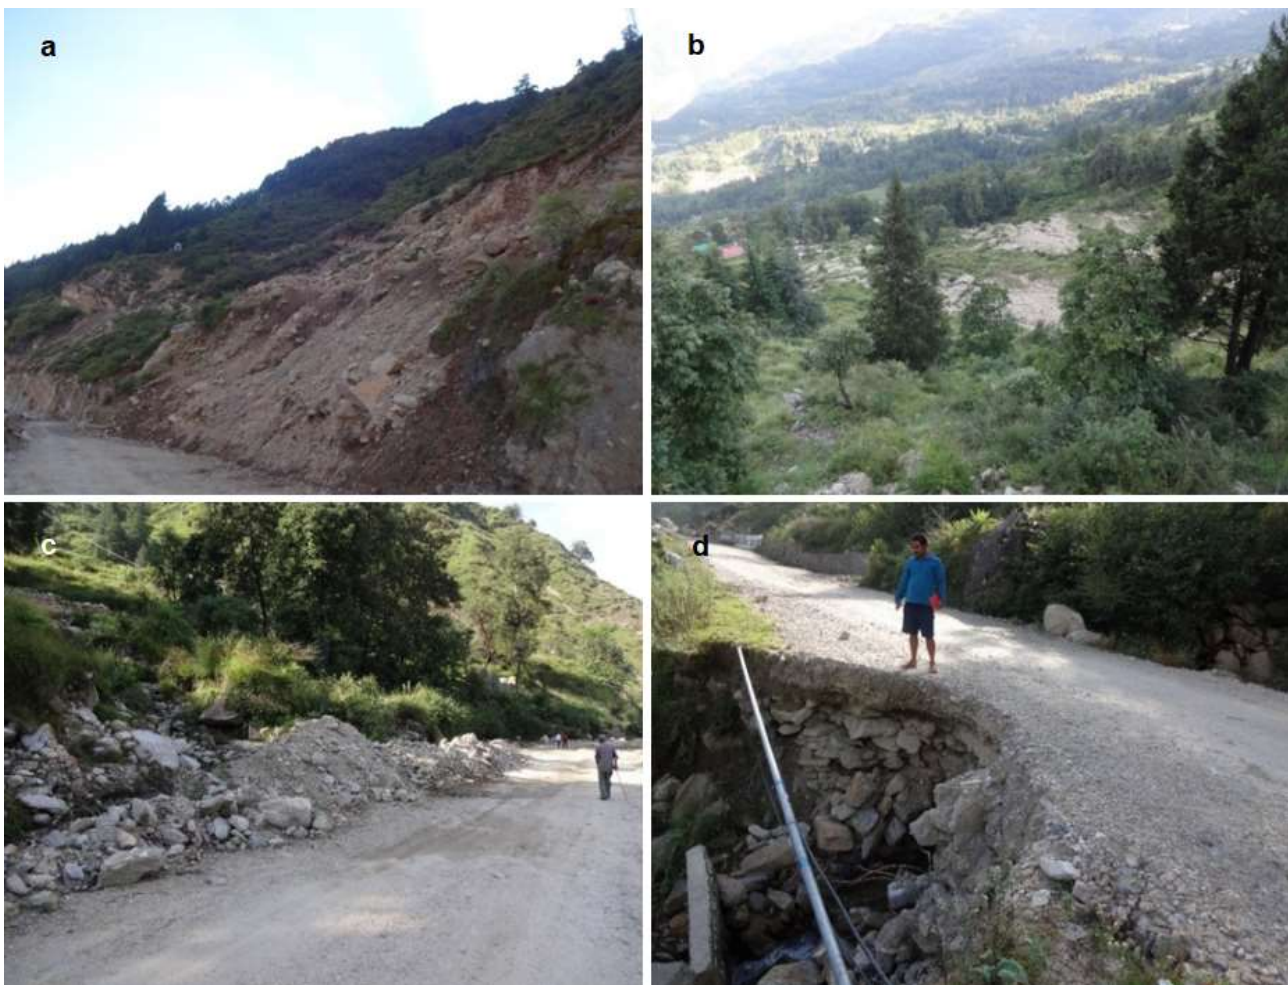
Rocks exposed in the area are generally observed to strike NE-SW with moderate dips towards NW. Other two prominent joints were observed to dip towards SSW and NNE at steep angles ($65^\circ/200^\circ$ and $65^\circ/35^\circ$). Indiscriminate hill side cutting for road widening and unplanned debris disposal along the road aggravated the problem during spells of heavy downpour (Fig. 5a). This debris that descended down from the area upslope of the tok was observed to have overrun both agricultural fields and partially damaged some houses (Fig. 5b). This debris materials are observed to comprise of hill wash and debris consisting of gray to grayish brown, fine grained silty matrix with rare boulders and fragments of gneisses and metabasics. There was a partially constructed toe drain along the hill side Munsiyari-Madkot Road which was found insufficient to carry the monsoon discharge (Fig. 5c).

Fig. 5. Heavy rains triggered debris flows and related damages in Balta Tok; (a) undercutting of hill slope for road widening; (b) debris flows from uphill road overrun agricultural fields and houses; (c) severely damaged culvert due to excessive water saturated debris discharge by local stream; (d) unlined and chocked hill side drain on road due to debris flows

A small perennial stream having gentle to moderate slopes was observed to flow through the area. Water saturated debris flows through this stream which had severely damaged the culvert and overflows through the road due to heavy precipitation (Fig. 5d). It was observed that the size and gradient of the culvert was not enough to pass the desired discharge. In the proximity to this stream a gully has

Recommendations: The hill slope cutting for widening of the road around the Suring bend area posed threats of slope failure to the downhill side habitations. Therefore, suitably

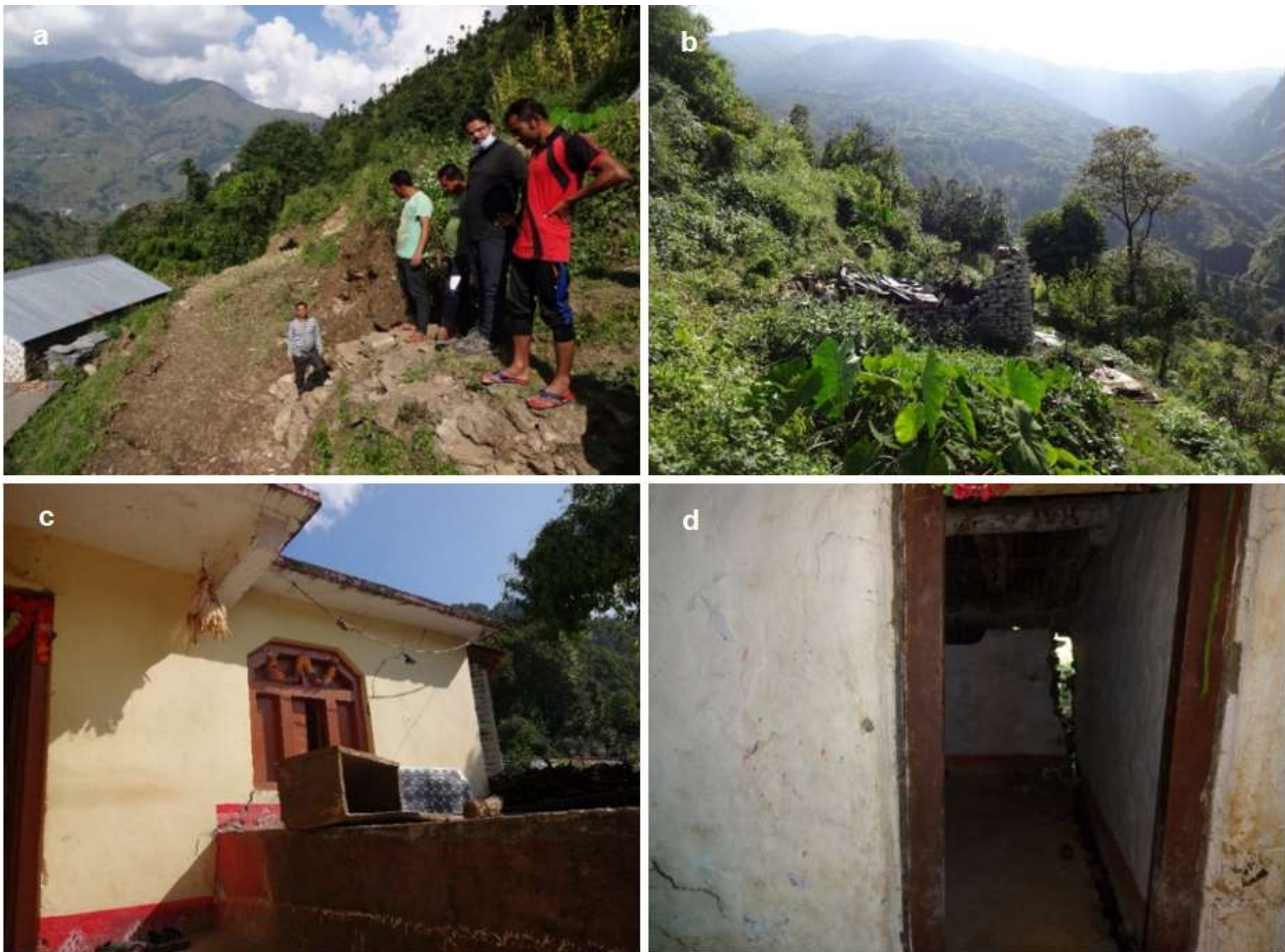
The ground fissures in the agricultural fields are observed to be up to 4.0 meters long (Fig. 7a). The subsided material lying on gentle to moderate slopes has developed tension cracks which was trending from NE-SW on the same area. Total of 2 houses were ruined in the same incidence (Fig. 7b). As also, cracks were observed to be in a number of houses (Figs. 7c and 7d).

Fig. 7. Ground subsidence related damages in the Malupati Village; (a) ground fissure in agricultural fields, (b) collapsed a house, (c) crack in a house and (d) detached back side wall of a house

Downhill slope of the village is observed to be affected by landslide. The same was occurred due to the toe erosion by the Bharadi Nadi on its right bank. The width of the failure slope is around 100 to 300 meters along the Northeast flowing Bharadi Nadi while the height of the slide from river bed to the crown is about 50-70 meters. The inclination of failure slope is observed to be around 35° . The Southeastern proximity to fresh ground fissure zone, a small seasonal stream is to be observed in the area. The same is flowing through the old landslide which was observed below the village area. Apart from, seepage was also observed in the agricultural fields between fresh landslide and old landslide in the area. Whole habitation of the Malupati Village is under high risk due to landslide and subsidence.

Recommendation: Presently, the Malupati Village is facing serious slope stability problem where whole habitated area is affected by active subsidence whereas downslope is affected by toe erosion of the Bharadi Nadi. These factors have critically affected the stability of the area. During investigations, wide cracks were observed in the walls and floors of many houses that indicating active slope movement in the area. It is therefore advisable to rehabilitate the Malupati Village to an alternate safe location.

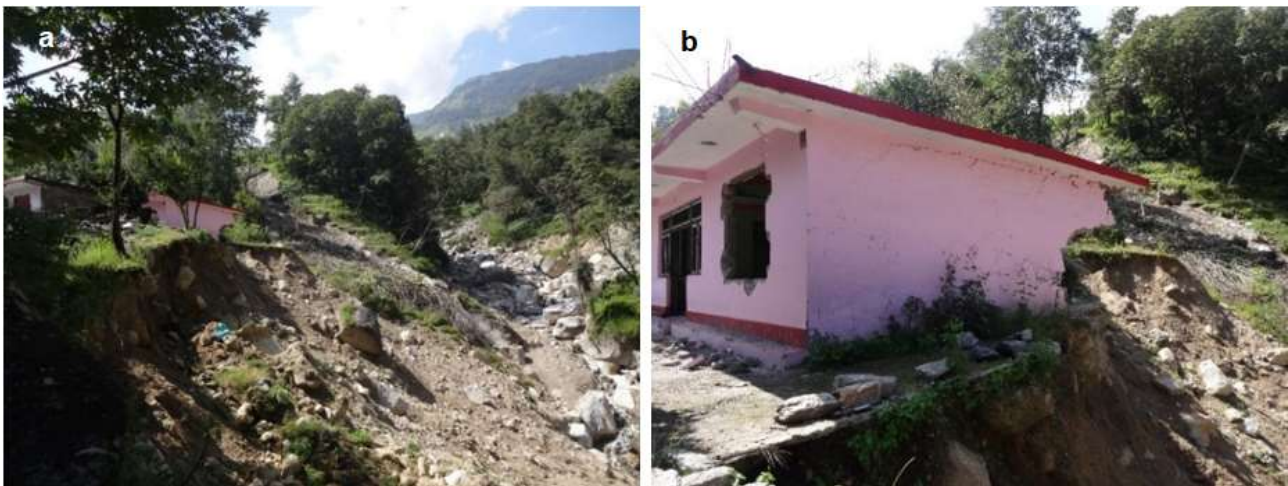
Toe erosion caused by spate in Dhapwa Gad during excessive rainfall events in this valley was observed to have contributed to the stability of the slopes in this area. The terraces of the tok were observed to be eroded by this stream. An eroded terrace having vertical slope at crown portion whereas moderately steep to steep slope between middle to toe portions with the slope direction being NNW. The width of the failure slope was about 50 meters and vertical height of the slide was from 15-20 meters. A house located just above the crown of this destabilized terrace was observed to be severely damaged and in highly vulnerable state (Figs. 8a and 8b). As also, slope failure was occurred on the opposite

Fig. 8. Severally damaged a house due to toe erosion by Dhapwa Gad; (a) on the edge of failure terrace and (b) close view of the same house

Recommendations: The house which was damaged severally by flooding of Dhapwa Gad is not found suitable for living. It is therefore highly recommended that immediately demolished the same and displaced the habitations at safer place. Further construction of house in the same must be prohibited in the area. At least 5 meters buffer zone to be kept from eroded terrace cut and construction of houses in the same zone should not be allowed. Appropriately designed retaining structures of suitable height with firm foundation are required to be erected on right bank along the affected area for checking the toe erosion by Dhapwa Gad. This would help in protecting the agricultural fields from further extension of slide at affected site as well as bank of Dhapwa Gad from stream erosion.

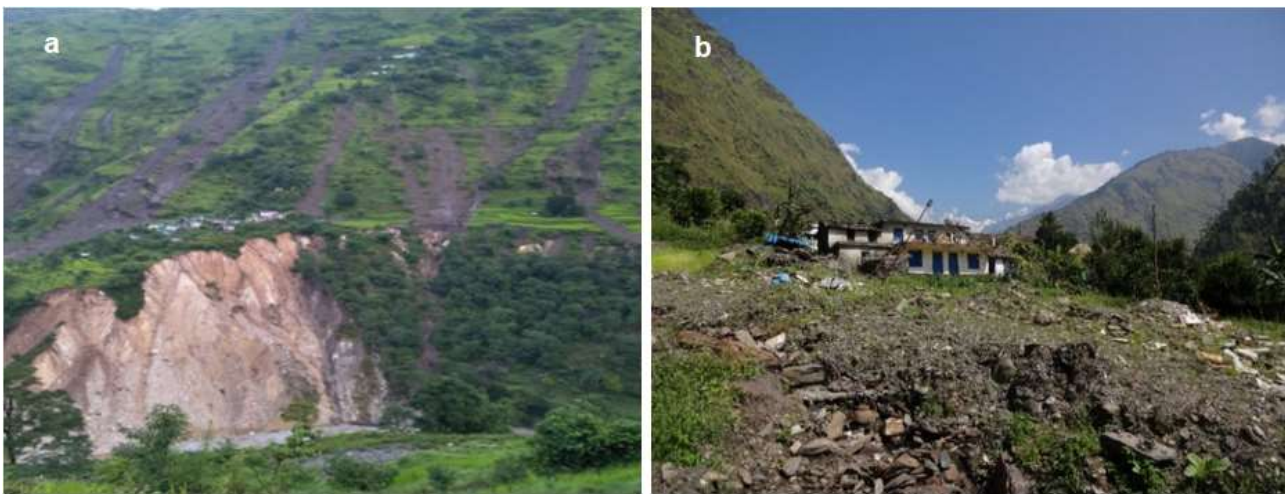
The Southwestern proximity to the village area, West flowing seasonal stream is observed to have overrun the agricultural fields and had create deep gullies in the area. This directly hit habitations of which some proximity to its course. As many as 11 persons lost their lives, of which one person was injured and body of one person could not be recovered together with 12 animals were lost in these incidences. A number of agricultural fields were also damaged and total of 4 houses were destroyed in these incidences (Fig. 9b).

The upslope of the Tanga area was triggered by many superficial landslides and downhill of the same was eroded by bank erosion of the Pena Gad during excessive rainfall events. This was observed to have contributed to the stability of the slopes in this area. An eroded terrace with sub-vertical

cut around of 40-60 meters was observed on the right bank of Pena Gad just below the entire stretch of the village area indicating active movement in the area.

Fig. 9. Heavy rains triggered landslides and associated damages; (a) numbers of superficial landslides whereas downslope affected by Pena Gad and (b) the place where houses were destroyed along with casualties

Recommendation: The upslope of the Tanga Village was triggered by many superficial landslides whereas the downhill movement of the upper crest all along the village due to toe erosion by Pena Gad indicates that active slope movements in the area. Therefore, no remedial measures will be sufficient considering the location and risk involved, hence permanent rehabilitation of the Tanga Village to safer location is recommended.

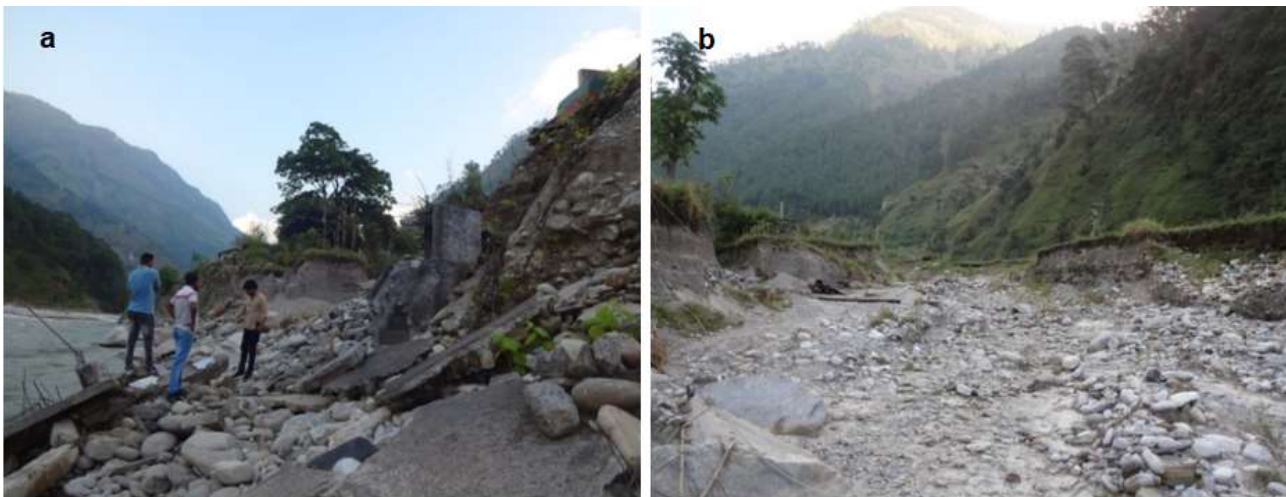
Bank erosion caused by spate in Goriganga River during excessive rainfall events on 20 July, 2020 in this valley was observed to have contributed to the stability of the terrace in Choribagar Tok of Bangapani Village. The area around the tok was observed to have thick overburden and its thickness was up to 7 meters. This overburden material was observed to comprise of river borne materials that consists of grey, medium grained sandy matrix with rounded boulders, cobbles and pebbles. The river terrace was observed to be cut vertically by Goriganga River. An eroded terrace with vertical cut around of 3-4 meters was observed on the left bank of the same. Total of 7 houses were destroyed and

washed away in flooding of the same (Fig. 10a). The Goriganga River is observed to be shifted its course towards tok by 20 meters approximately due to excessive flood discharge in the river and has contributed to the erosion of the terrace.

A seasonal stream flowing from NW-SE direction was observed to flow above the road head through the agricultural fields and habitations of the tok (Fig. 10b). A number of agricultural fields were observed to be eroded by the same. This has removed the sediments and made deep gully as well as destroyed the houses which were located along its course.

Fig. 10. Bank erosion and gully erosion related damages in Choribagar Tok; (a) eroded terrace with destroyed houses and (b) eroded agricultural fields by local stream

Recommendations: A seasonal stream above the road area which has formed gullies in the agricultural fields of the tok. This stream should be properly channelized up to the Goriganga River. This would help in reducing further gully erosion by doing the same. Appropriately designed flood protection structures with firm foundation against suitable flood value are required to be erected for preventing toe/bank erosion by Goriganga River. This would help in protecting the agricultural terraces as well as bank of the same from bank erosion and hitting actions of large rolling boulders. At least 10 meters buffer zone to be kept from eroded terrace cut and construction of houses in the proximity to the affected site should not be allowed.

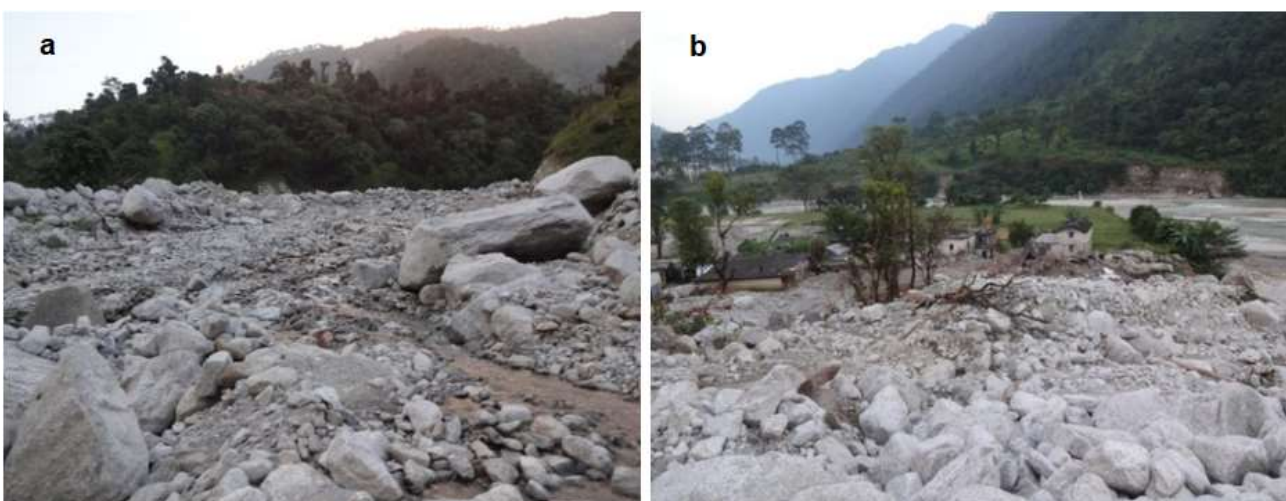
downstream side the habitations of Tall Mori Tok of Bangapani Village are situated on the river born materials terraces. In this incidence 11 houses were destroyed while 15 houses were severally damaged (Fig. 11b). Apart from, a number of agricultural fields of this tok were also damaged and filled with debris and big boulders (2-3m dia.). The thickness of debris with boulders is to be observed around 2.0 to 5.0 meters at the site.

Fig. 11. Flooding of Mori Gad and associated damages; (a) deposited sediments and diverted the flow of Mori Gad and (b) destroyed houses and partially damaged houses along with agricultural fields filled with sediments

Recommendation: The erosion action of both Goriganga River and Mori Nala contributed to the stability of the Talla Mori Tok. Settlements of Talla Mori Tok had already been affected by flooding of Goriganga River and Mori Nala. Because of the same this area is highly vulnerable to flooding further it is not economical to clear the deposited debris in the whole area and will create future threats to tok particularly during monsoon. It is therefore advisable to shift the entire tok to an alternate safe location.

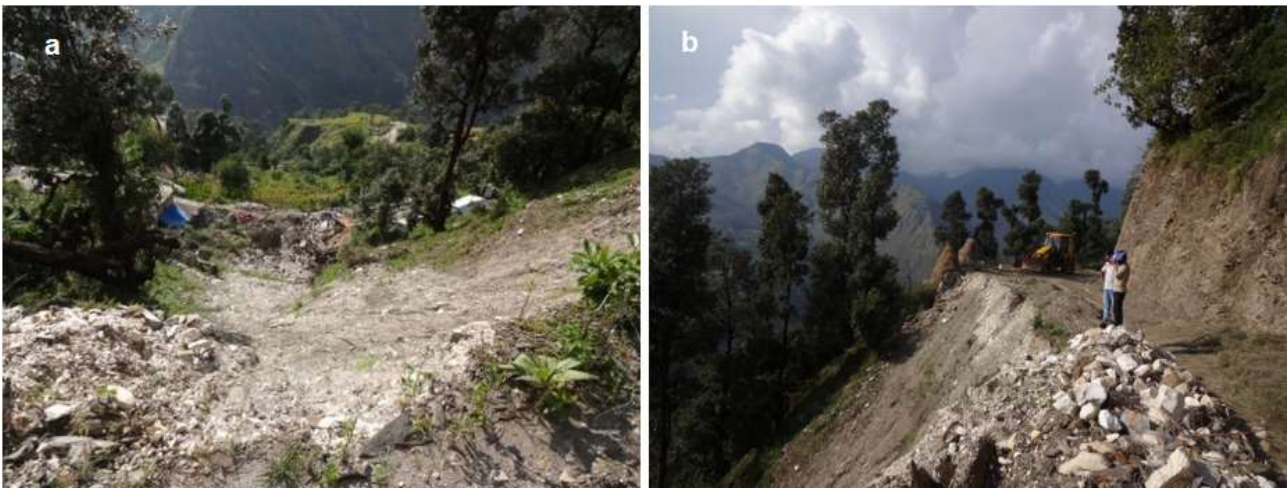
Newly under construction road valley side slope triggered after heavy rainfall of 20th July, 2020 at Gaila Malla Tok in Pattharkot Village of Bangapani Tahsil. Debris slide is observed to have occurred on the West slope of tok. The inclination of failure slope is observed to be 60° - 70° . The width of the failure slope (damaged road section) is about 40-50 meters at the crown portion and height between toe and the crown is about 55-65 meters (Figs.12a and 12b). Thick pile of loose debris along with wire crates retaining structures

that descended down from the area upslope of the tok is observed to have badly hit both agricultural fields and a house. As many as 3 persons of a family lost their lives in the same incidence. As also, the South proximity to the failure slope just below road area, there is a wire creates retaining structure which was observed to be partially bulged and tilted. The same is posing risk to a house which is located downhill of its.

Fig. 12. Slope failure at Gaila Malla Tok in Pattharkot Village; (a) failure slope above destroyed house (b) damaged portion of under construction road

Recommendations: The road should be shifted towards hillside along the affected slide zone. After this suitably designed breast wall of appropriate height with weep holes should be constructed at road level. In case of South proximity to slope failure zone, tilted and bulged wire creates retaining structures should be reconstructed properly with due attention to actual ground conditions. It is also strongly recommended that construction of any sort should not be allowed around the affected zone. The households located below the same zone are required to be shifted to alternate safer locations.

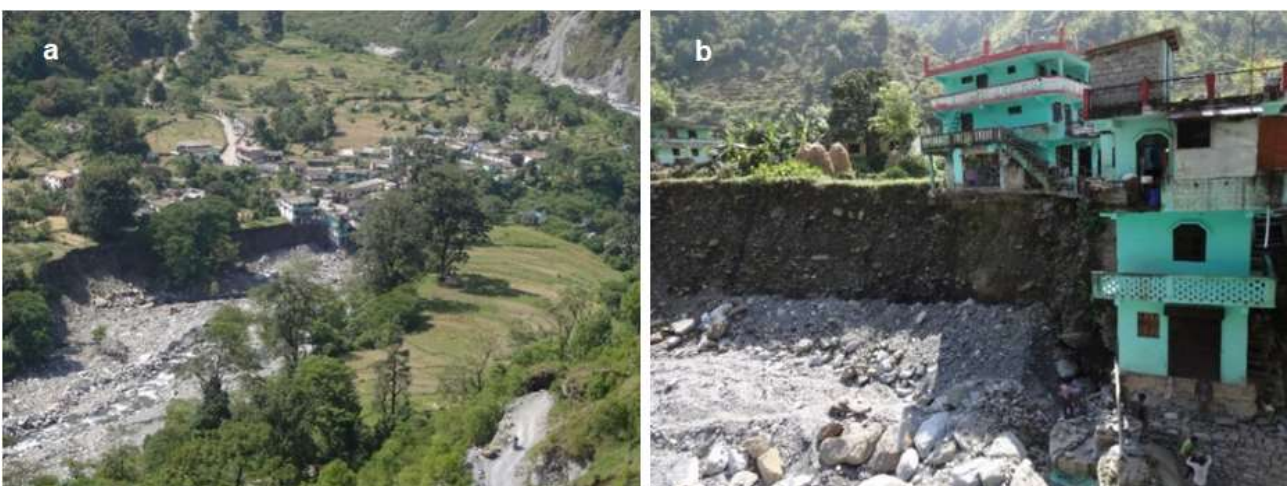
Fig. 14. View of eroded terrace with houses in vulnerable state on the left bank of Barar Gad; (a) panoramic view and (b) close view

spate in Gad has eroded the terrace on its left bank and has severely damaged the three buildings, as also numbers of agricultural fields just upstream of Bridge. Public toilet and a house were washed away along with a house was severally damaged and also safety walls of Panchayat Ghar as well as Government Intermediate Collage were damaged on the downstream of the Bridge. In this area, the Gad has eroded around 15-20 meters towards the left bank upstream of motor Bridge.

Recommendations: In order to protect the eroded terrace cut and vulnerable constructions, a suitably designed protection wall should be constructed with firm foundation. This would protect the terrace as well as bank of Barar Gad from stream erosion. No further construction should also be allowed in this zone. Similarly, slopes in the downstream should be stabilized with suitably designed retaining walls all along the banks of Barar Gad, in order to protect the Panchayat Ghar and Government Intermediate Collage.

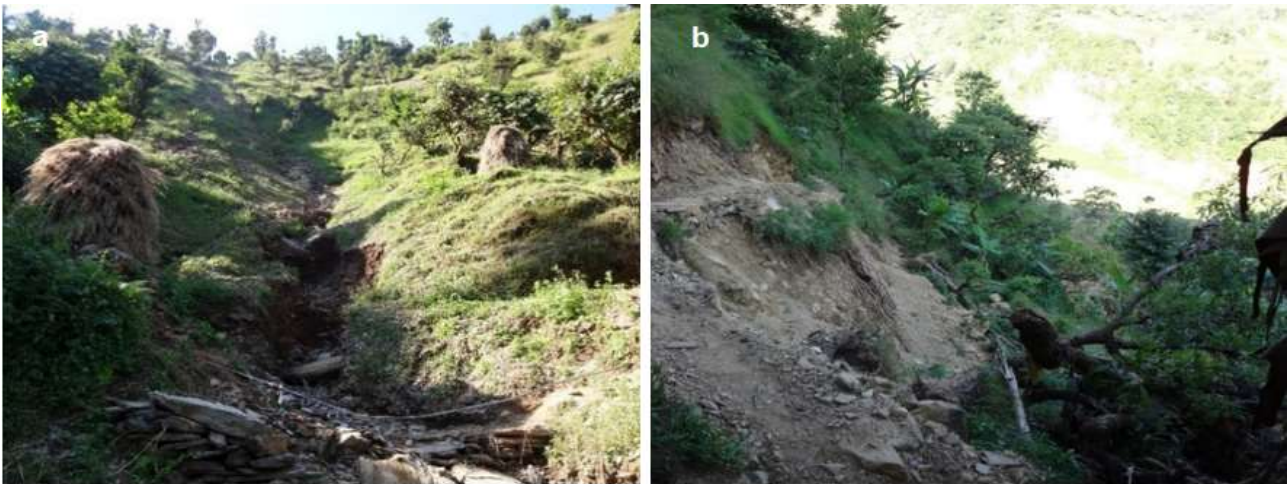
Fig. 16. Damages during rainfall in Dhami Tok; (a) Gully erosion by seasonal nala and (b) the ground fissures in the agricultural fields at Dhanari

Mostly, exposures of Lesser Himalayan slates were observed on the upslope side of the village as also along the road section. However, boulders of tuffaceous rocks were also observed at Dhanari subsidence zone along the foot track section. The bedding plane was generally observed to be well developed and dips at angles 30° towards northeast. The joint sets were observed to have steep to sub-vertical dips towards SW and SE respectively ($75^\circ/240^\circ$ and $85^\circ/130^\circ$). The ground fissures in the agriculture fields are observed to be up to 3.0 meters long at Dhanari in Sarwa Dhar area (Fig. 16b).

Around 50 meters foot track stretch was also completely damaged in the same place. The subsided materials lying on gentle to moderate slopes having with numbers of tilted trees which indicating active soil movement. The failure slope is observed to have occurred on the ESE slope. The overburden thickness is observed to be more than 8.0 meters in the same area. This material is observed to comprise of hill wash and debris consisting of brown, fine grained silty-clayey matrix with rare boulders of limestone/tuffaceous rocks and fragments of slates.

Recommendations: In case of a small seasonal nala, check dams with wire crates along the nala course should be placed for checking stream erosion in the area. The toe of the Dhanari ground fissures zone should be protected by appropriately designed retaining structures. This will protect the movement of critical slope mass in the area. It is also required that anthropogenic intervention of all kinds be strictly regulated in the proximity of seasonal nala and ground fissures zone. So, the villagers are advised to stay away from these places, particularly during heavy rainfall.

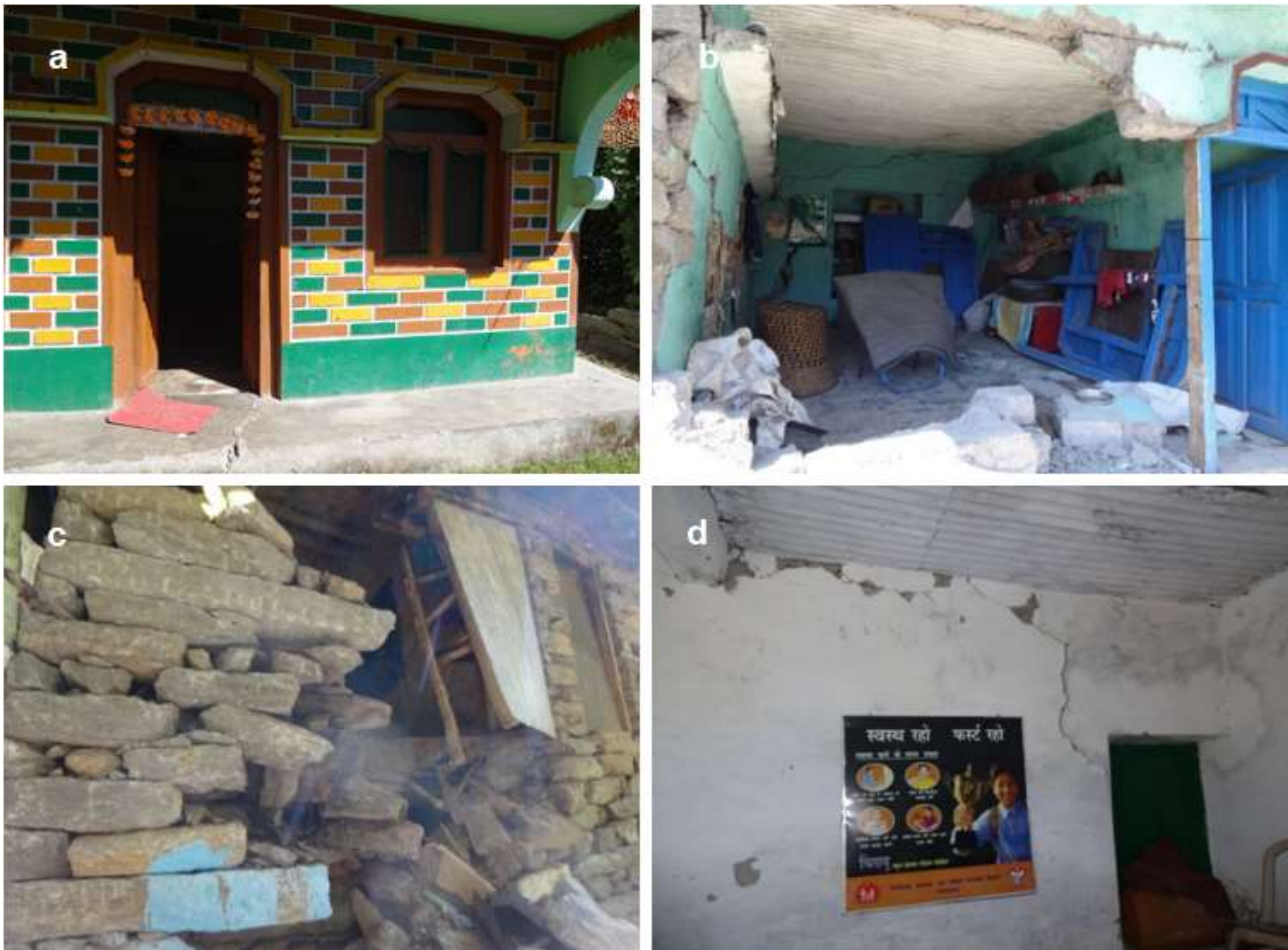
Fig. 17. Cracks in houses of Khela Village due to creep movement; (a) cracks in house at Ala Tok, (b) severely damaged house at Kolpani Tok, (c) damaged right-side wall of traditional house at Chetkala Tok and (d) cracks on roof column and wall of primary school at Chetkala Tok

Recommendations: Cracks were observed in the most of the houses that indicating active slope movement in the area. The hill slope around Khela Village is deduced to be highly susceptible to failure, particularly in the event of heavy or prolonged rainfall. The residents are therefore advised to stay away from the active creeping zone, especially during heavy or prolonged rainfall. The households of the all three toks are required to be shifted to alternate safer locations. Cracks on floor, roof column and walls of primary school at Chetkala Tok are indicating major settlements in the ground. It is highly recommended that the Primary School located in active creep zone be vacated and put to disuse immediately.
