Cracking and Causes of Ground Displacement in Rawat Rawalpindi Pakistan (Causes and Effect Report)

Numerous fault and fold system are found in Pakistan and its surrounding region which is tectonically active region in entire Asia subcontinent. This research is related to earthquake happened at 24 July 2015 in Islamabad, Pakistan. A policed constabulary building hit by moderate earthquake causes to produce damages at significant level. Their cracking, settlement and ground displacement open the new door of research. This report is generated after field visit under supervision of senior engineering and geologist. Rawat Fault was a sourced which is thrust fault due to Jhelum strike slip fault mechanism. Deep cracking was observed in and outside of wall due to breaking of plaster. Minor level of ground displacement which is about 2 cm to 3 cm was observed during field in the direction of fault lines. Further more intense tectonic area including Rawat Fault which is part of Jhelum Fault is an active fault in the regime. Three numbers of pit were excavated to observe the settlement of sub surface soil. At few places settlement was pointed due to seismic wave propagation and there is no

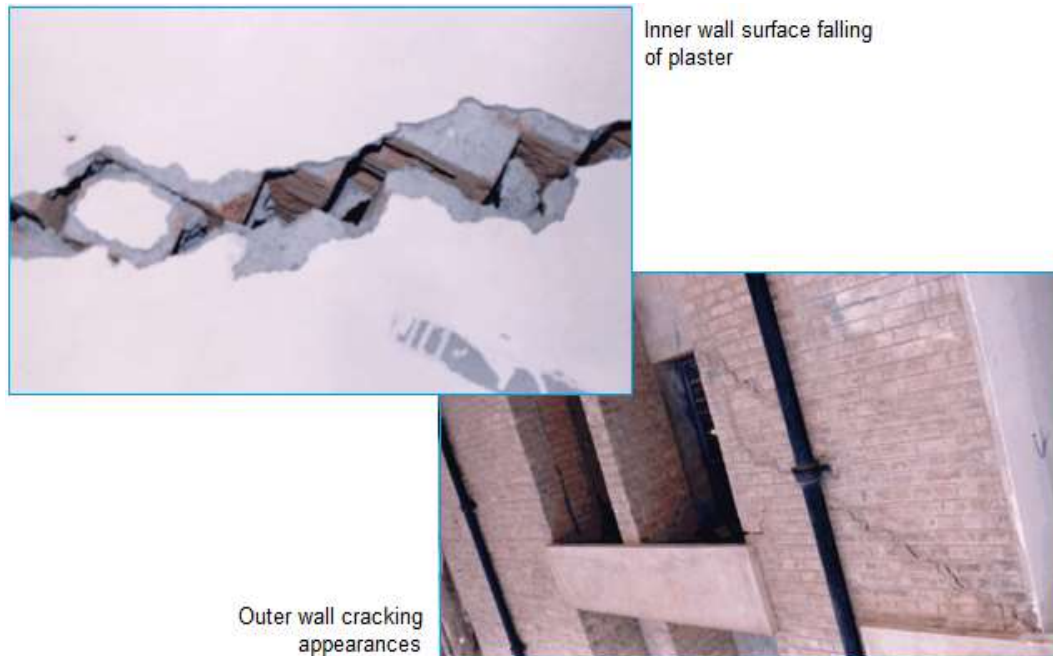
Fig. 6. Fissure and cracking on the wall after earthquake impact

located south of Rawat town [located on rock out crop]. The Rawat Fault plain shear zone may pass through or close to this site. Another influencing geological structure of area is the Mankiala anticline. Which also plunges south east of Rawat Fault and constabulary site. the fissure and cracking portion of building can be seen in the (Fig. 6).

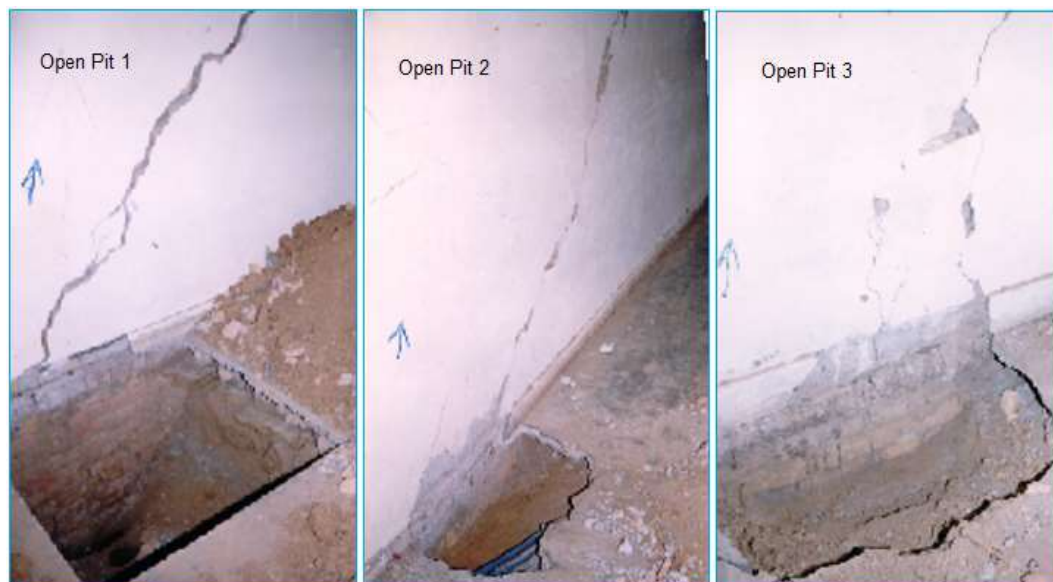
Fig. 7. Open pit settlement behavior of subsurface soil

Stresses propagating south east which may have been supplemented by liquefaction of sensitive clays with sand parting may have led to the shear deflection of residential barracks and leaning/distortion of commandant’s office in south east direction. Various researchers had documented the seasonal shrinkage of clay soils under shallow foundations of structures as a result of vegetation growth. It had been
