# Stability Assessment of Rock Slopes at Former Quarries in Singapore

Kar Winn<sup>1,2\*</sup>, Chow Weng Lee<sup>3</sup>, Ong Perng Fey<sup>4</sup>, Htet Aung Linn<sup>5</sup>

Stability Assessment of Rock Slopes at Former Quarries in Singapore. *International Journal of Earth Sciences Knowledge and Applications* 8 (2), 202-222.

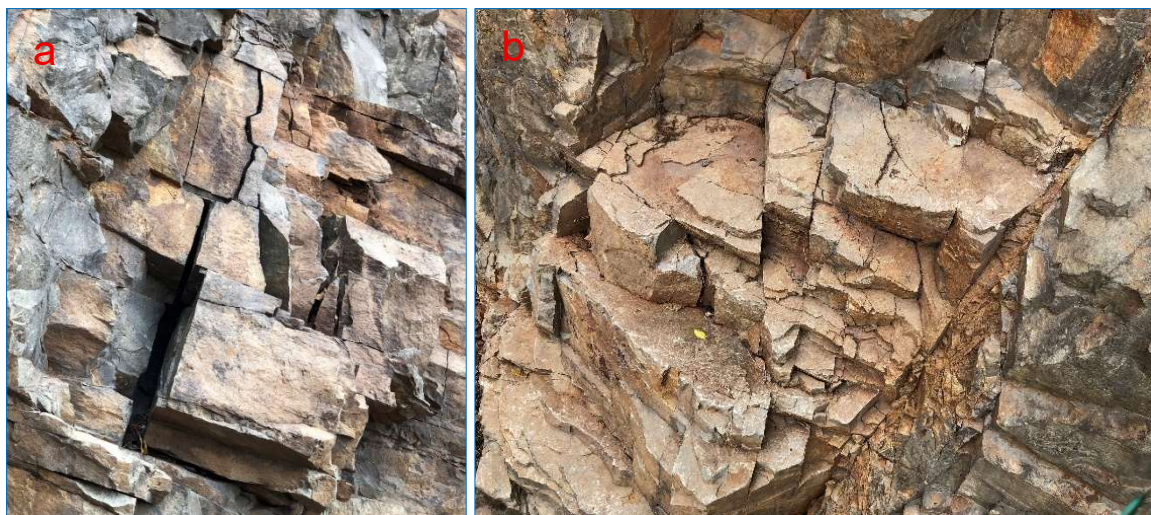
Fig. 6. a) and b) Observed loosely attached rock pieces on different locations on rock slope (Project 1)

Loose rock fragments of varying sizes (Fig. 6) were observed at different locations on the slope. These were formed during previous drill-and-blast quarrying operations and remained after incomplete scaling.

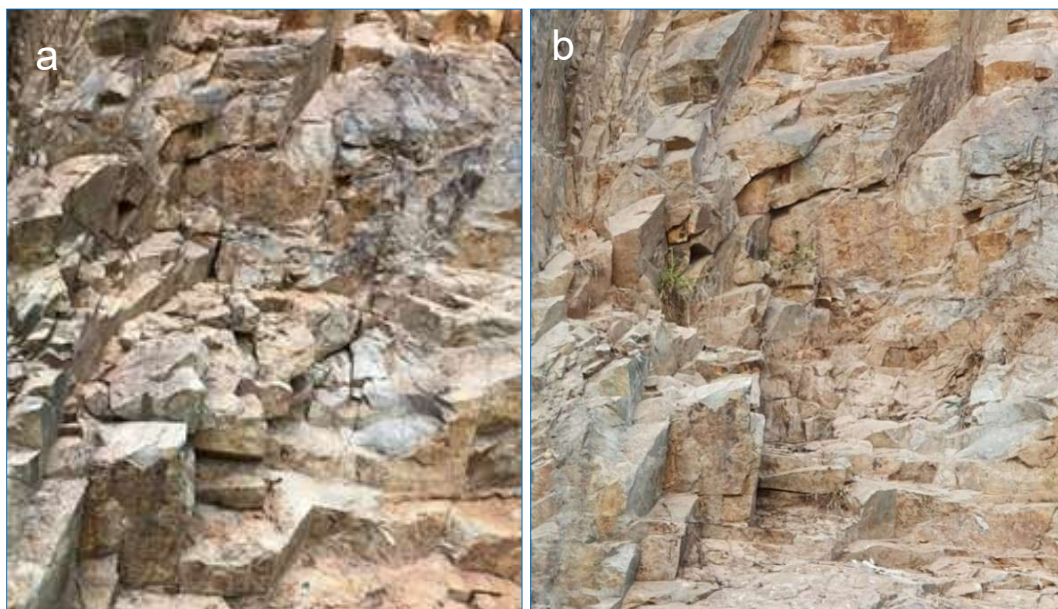
Fig. 8. Comparison of rock slope condition at some selected locations (Project 1): a) before scaling work and b) after scaling work

slope of  $70^\circ$  is stable. Comparative photographs of the slope face before and after scaling are shown in Fig. 8. The overall slope condition after scaling, with the Colugo Deck structure installed at the cliff top for public viewing, is shown in Fig. 9. Stabilization measures such as rockfall protection meshes and anchoring systems were not permitted by the authorities.

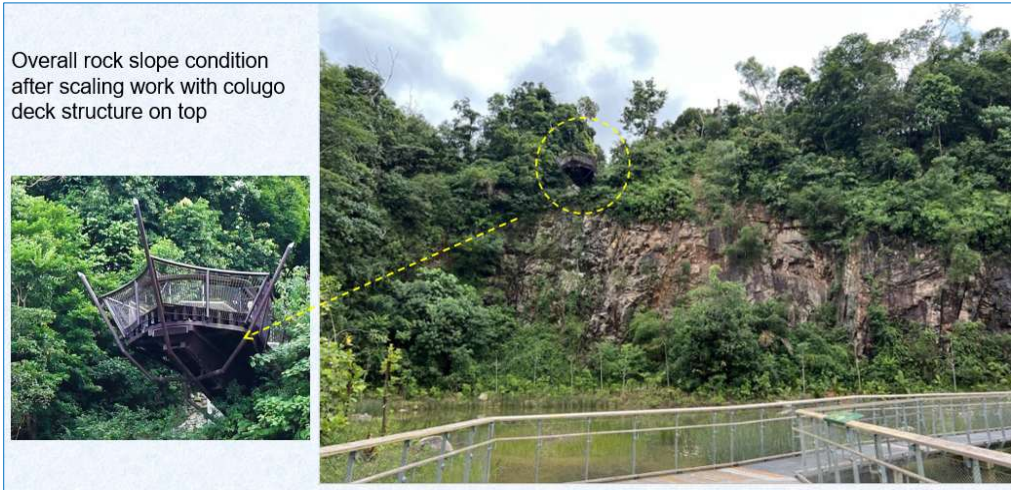
Fig. 9. Overall rock slope condition after scaling work with colugo deck structure on top (Project 1)

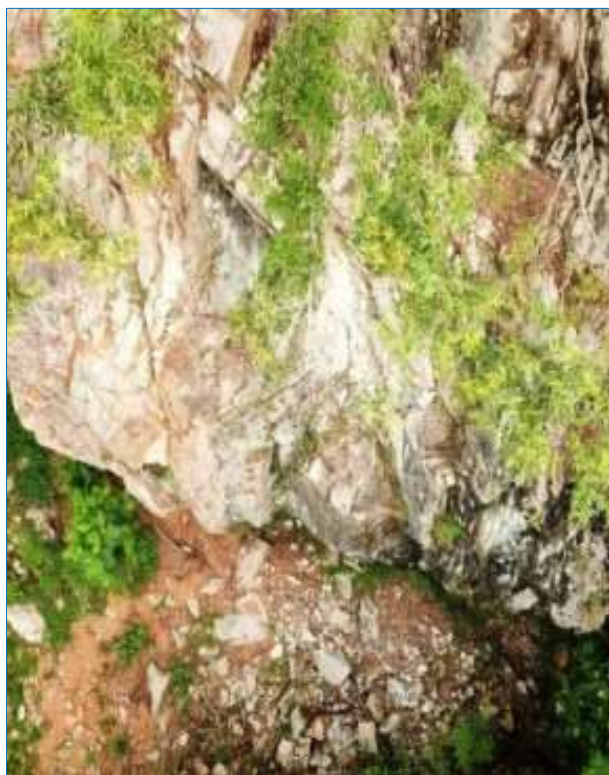
Fig. 12. White-coloured loose residual soil falling from slope top (Weathering effect-controlled rock slope failure)

- b. Weathering effect-controlled rock slope failure Fig. 12.

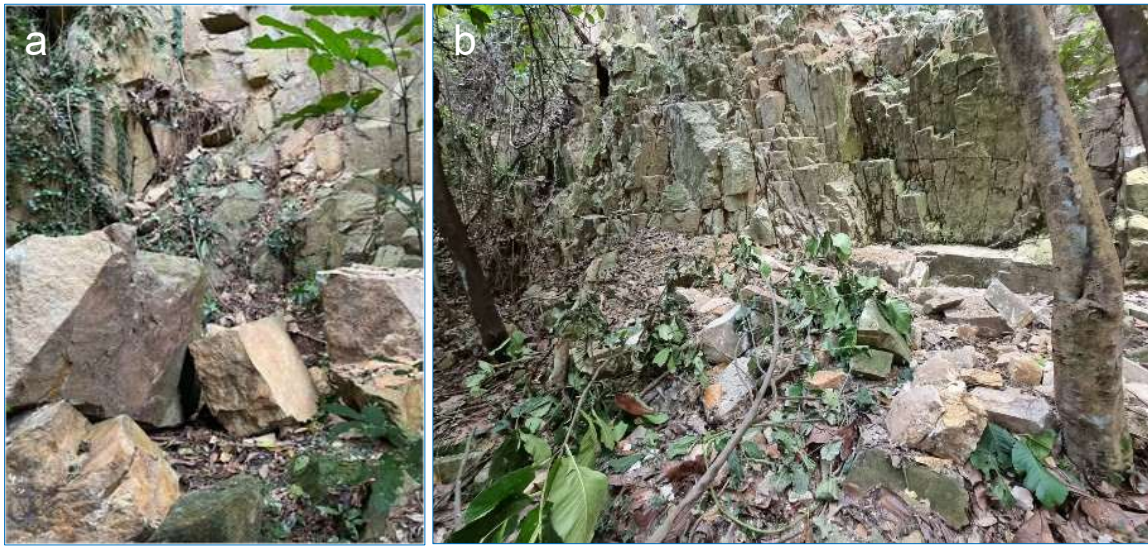
Fig. 14. a) Observed recent rock fall at Project 2 and b) Observed recent rock fall at Project 2

During the field investigation, several rockfalls were observed at specific locations, triggered by heavy rainfall and other natural hazards (Fig. 14).
